System Safety, Security and Operations Report

System Safety, Security and Operations Committee

October 15, 2015

Gold Line Service Disruption

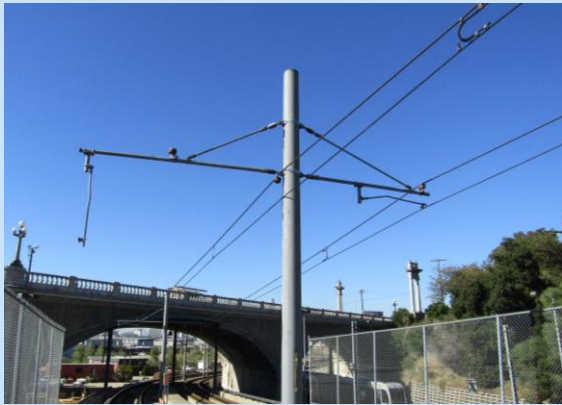
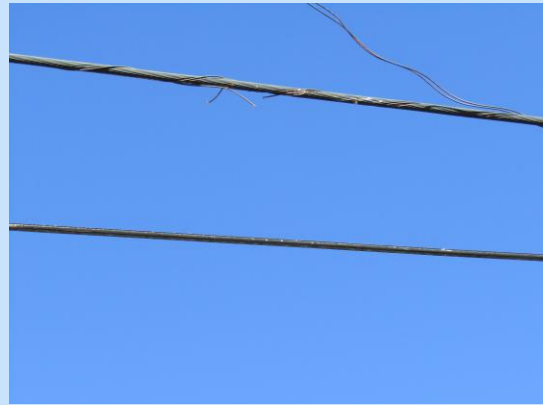
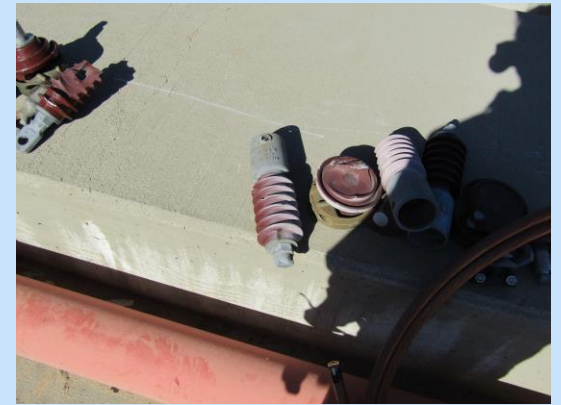
- Northbound Gold Line train reported overhead wire and pantograph damage north of Chinatown Station
- Customers evacuated to adjacent train; others evacuated down the employee stairway
- Single track established
- Bus bridge requested
