**Los Angeles County
Metropolitan Transportation Authority
Office of the Inspector General**

**Review of Metro
Safety Culture And Rail
Operational Safety**

Report No. 17-AUD-04

December 22, 2016

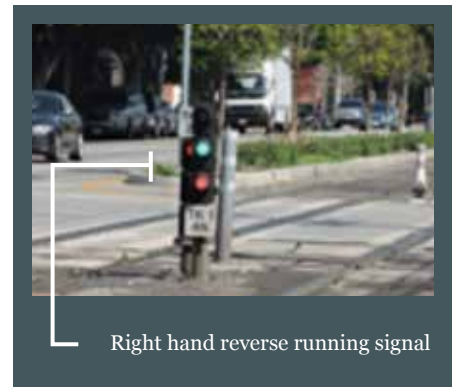
Although Metro has adopted a standard to install wayside signals on the left side of the track, many signal locations include right hand signals. This could lead to confusion on the part of train operators, especially at locations where normal and reverse running signals are installed side by side. Metro’s representatives indicated that the main reason for this deviation is to separate interlocking signals from traffic signals. However, it should be noted that reverse running signals are facing opposite to train traffic, and should not be visible to automobile drivers.

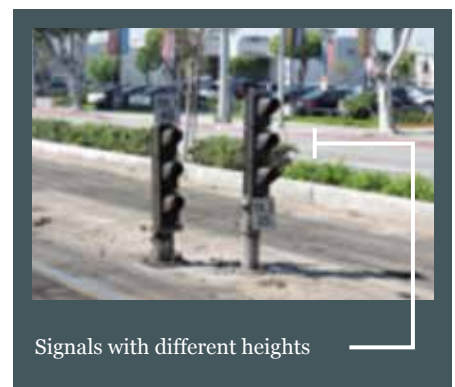
There is a lack of standards regarding the placement of wayside signals versus the Rail Operator’s direct line of sight. Signal height, for example, varies from location to location and in some cases a signal is raised in an attempt to differentiate it from an adjacent signal. This condition was also observed by the APTA Peer Panel.

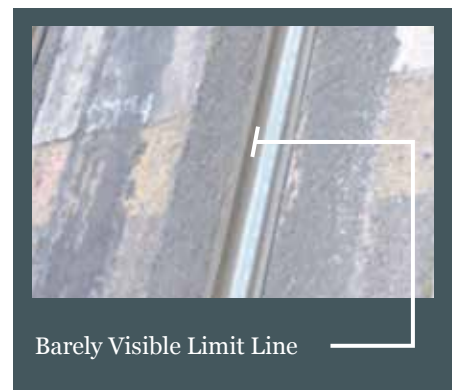
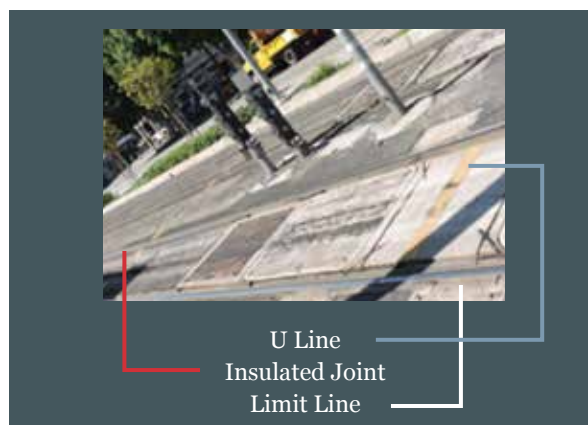
Further, at certain locations on the Expo Line, two yellow lines were observed in the vicinity of a signal location: the “Limit Line”, and a second line passed the signal at an insulated joint location (IJ Line).

A review of the Operating Rules and Procedures reveal that a “Limit Line” is not defined. However, a “Fouling Point Marker” is described. It is not clear if the “IJ Line” observed at certain locations is actually a “Fouling Point Marker”.

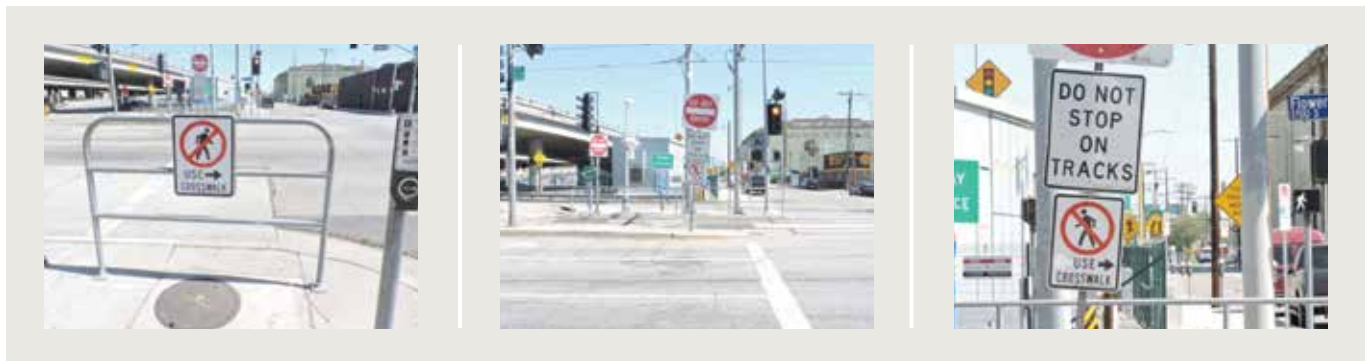
Signage

There are a number of pedestrian and vehicle signs that are missing at this intersection. They include:

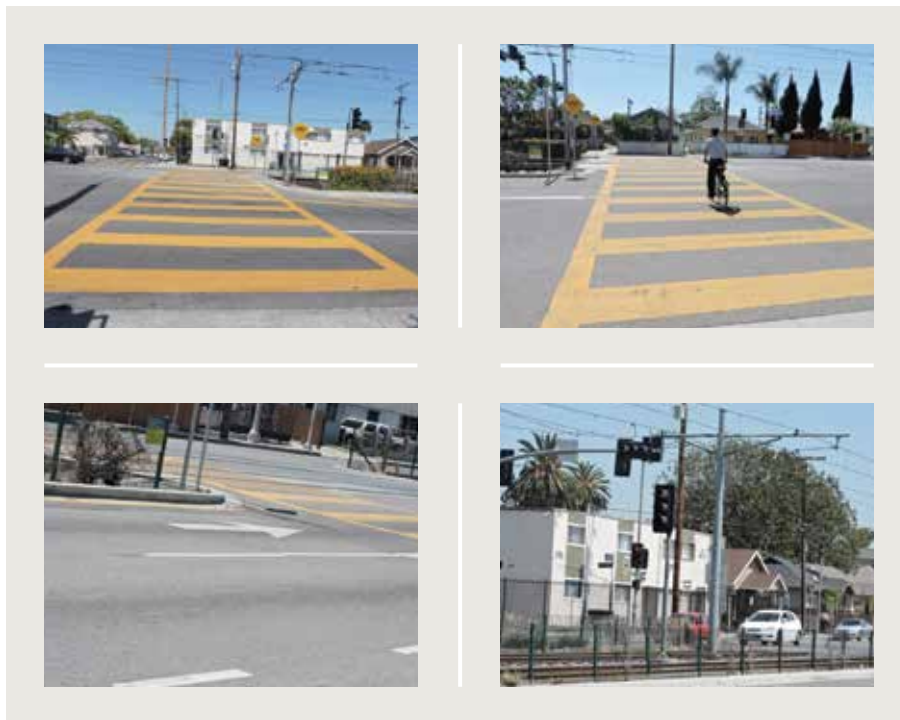
Street Markings

The street markings for pedestrians and vehicles at this intersection provide basic guidance for pedestrians to cross the tracks, and are in fair condition.

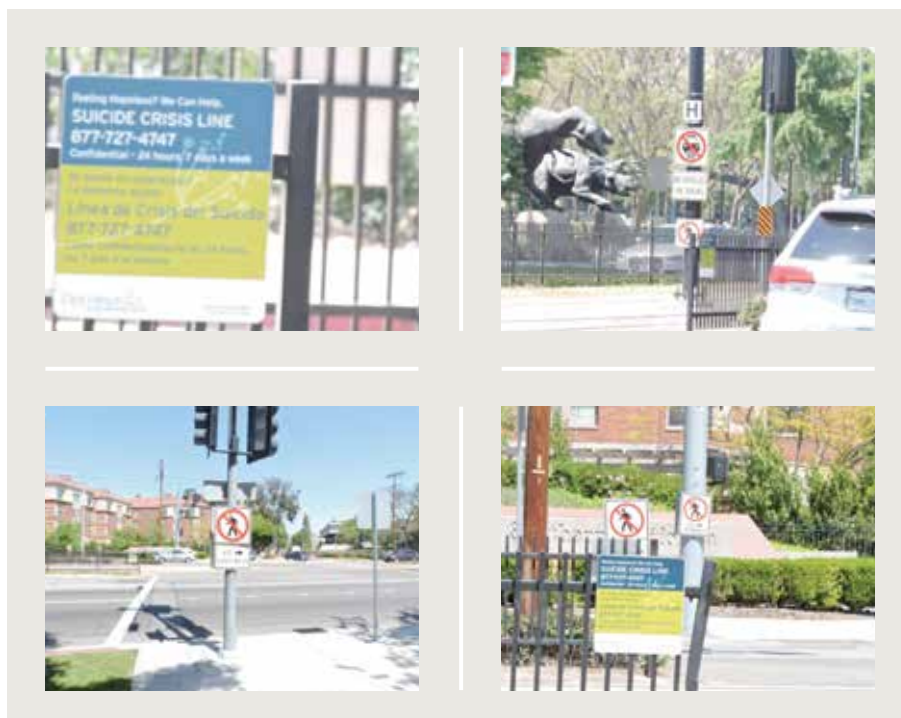
Signage

There are a number of pedestrian and vehicle signs that are missing at this intersection. They include:

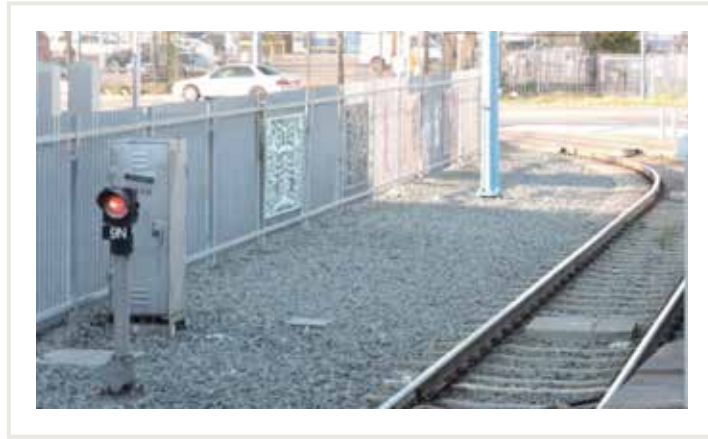
- Signal 9N is a reverse running signal located at the entrance to street running territory. It normally displays a “Red” aspect, and requires authorization from the ROC to proceed (Rule 3082). This signal is at the approach to a sharp curve.
