Key Observations from Ultrasonic Inspection

Photos of Fire Sprinkler System Components at Time of Ultrasonic Testing

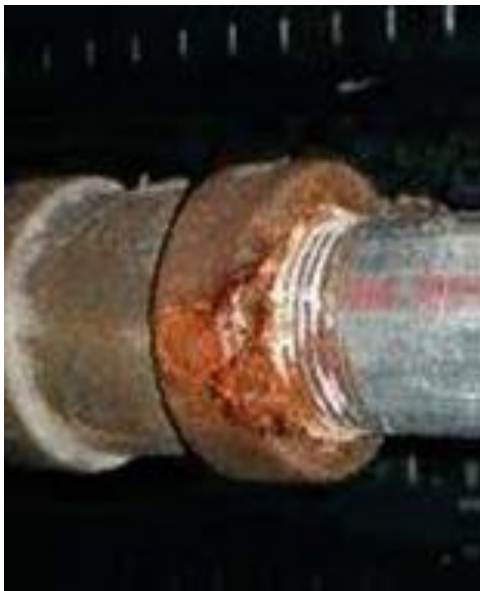
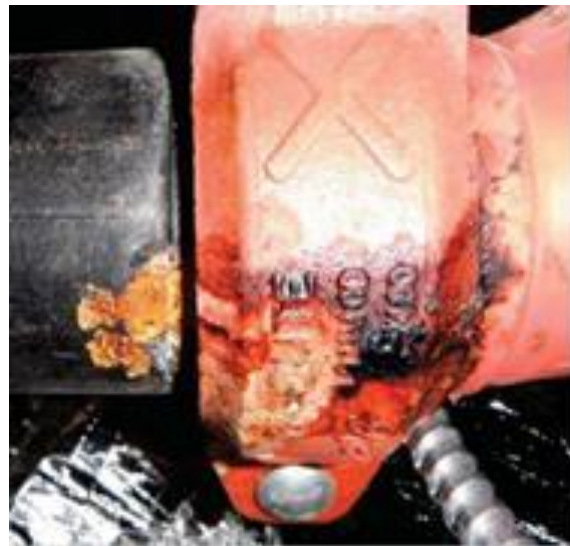
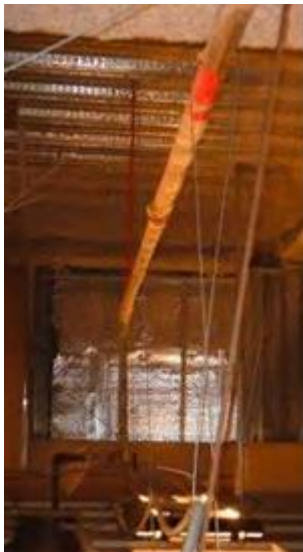
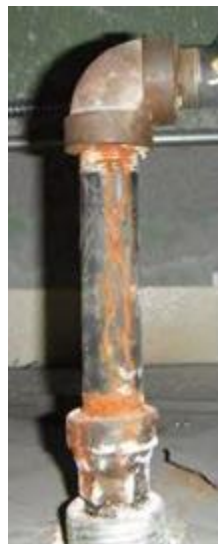
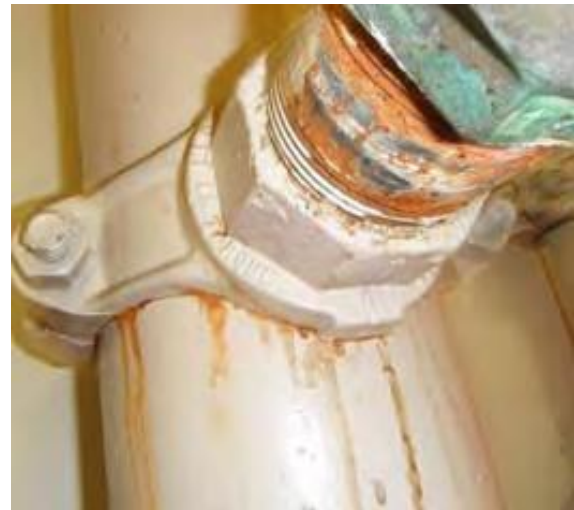
- Seeping seams found throughout building on threaded branch lines.
- 3-inch drain pipes running the length of the building showed severe issues..
- Over 65% of piping has interior wall loss of 11% or more.
- Air found within wet pipes on all floors.
- Trapped water found within pipes in the dry systems.
