ITEM 25

Overhead Contact System Update

Metro

May 2018

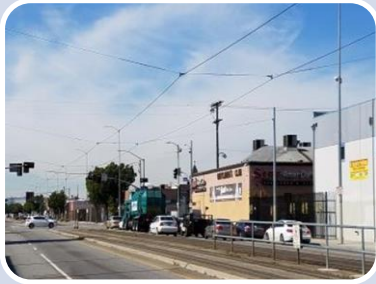
Single Wire Fixed Tension

- Street Running
- Slower Speeds

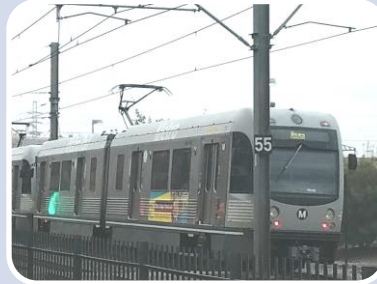
Double Wire Fixed Tension

- Messenger and Contact Wire
- Non-Street Running
- Faster Speeds

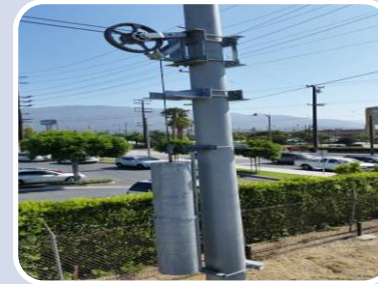
Double Wire Auto Tension

- Counterweight/
balancweight
equipment
- Dedicated ROW

90% of OCS is Double Wire Auto Tension which is the most challenging to maintain
