System Safety, Security and Operations Report

System Safety, Security and Operations Committee

October 15, 2015

Gold Line Service Disruption

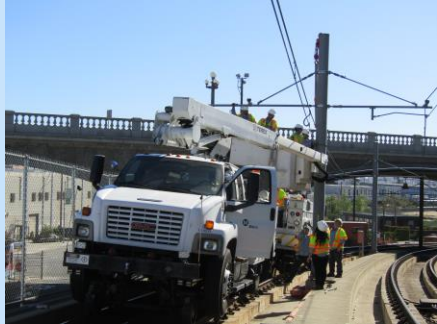
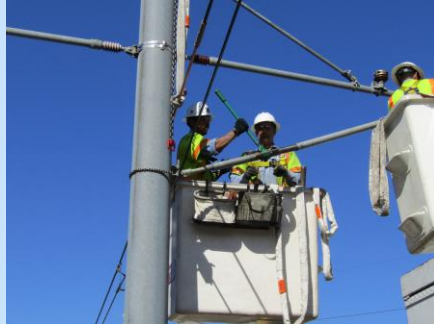
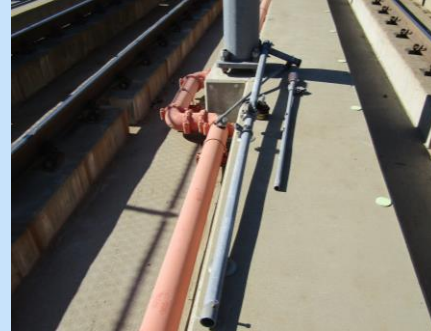
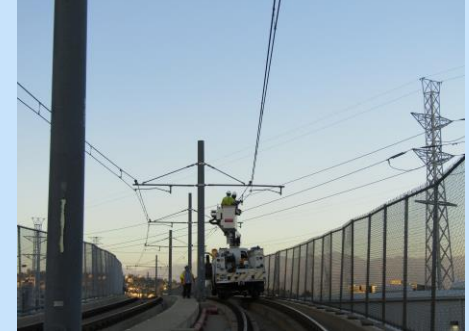
- Northbound Gold Line train reported overhead wire and pantograph damage north of Chinatown Station
- Customers evacuated to adjacent train; others evacuated down the employee stairway
- Single track established
- Bus bridge requested
