**Los Angeles County
Metropolitan Transportation Authority
Office of the Inspector General**

**Review of Metro
Safety Culture And Rail
Operational Safety**

Report No. 17-AUD-04

December 22, 2016

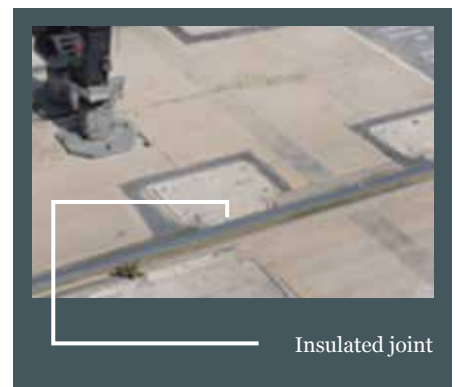
There is a lack of standards regarding the configuration of signal equipment at a signal location. For example, the relative location of the signal head versus the location of the insulated joint. On the Gold Line, insulated joints are located in advance of the signal head. However, on the Expo Line insulated joints are located after the signal head. It is important to establish an installation standard for insulated joints relative to the location of associated signal to ensure proper operation. A misplaced insulated joint could result in the cancellation of a signal in front of a train.

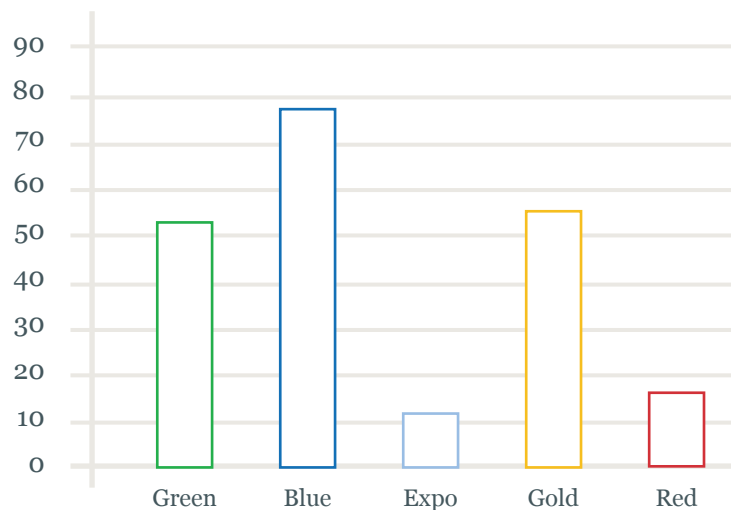
Metro Line	Total Failures	Characteristics
Blue	79	<ul style="list-style-type: none"> • Oldest signal installations - placed in service in July 1990 • 22 miles • Cab-signaling • Street running sections
Expo	12	<ul style="list-style-type: none"> • Newest signal installation - placed in service in April 2012 • 8.6 miles • Cab-signaling • Street running sections
Gold	55	<ul style="list-style-type: none"> • Placed in service in July 2013 • 31 miles • Cab-signaling distance to-go • Street running sections
Green	53	<ul style="list-style-type: none"> • Placed in service in April 1995 • 20 miles • Cab-signaling distance to-go • High level of automation • Dedicated right-of-way
Red	16	<ul style="list-style-type: none"> • Placed in service in January 1993 • 17.4 miles • Cab-signaling • Heavy rail installation

The following chart shows the distribution of signal failures for the various Metro lines:

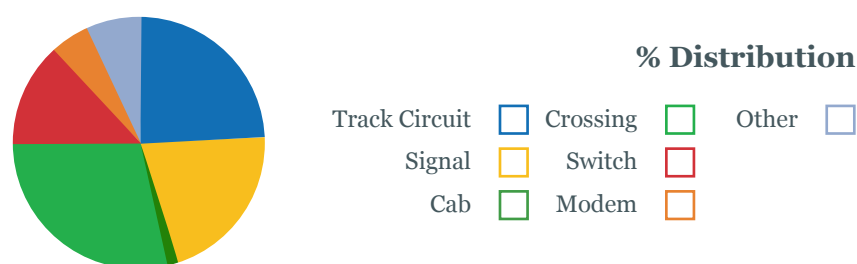
The above distribution shows that over 70% of signal failures are caused by conventional signal equipment including track circuits, signals and grade crossing devices. This demonstrates the advantage of new train control technologies that minimize the use of conventional signal equipment.

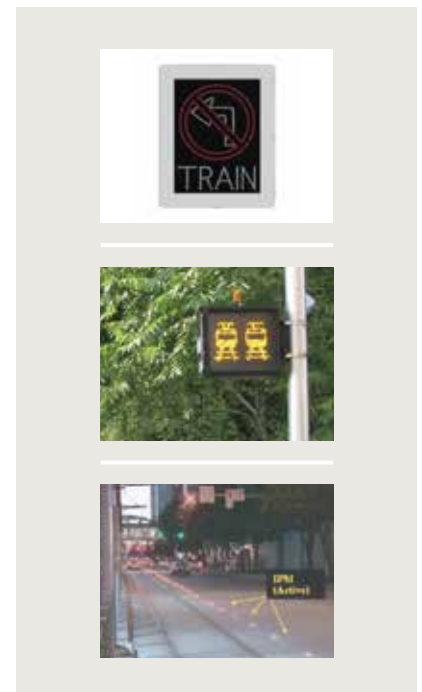
As indicated above the main factor that contributed to prior accidents is the unsafe behavior by the public in violating traffic signals. To enhance the safety of operation at this intersection, it is essential to undertake measures that will discourage unsafe public behavior. Therefore, in order to improve the safety of operation at the intersection, there is a need to focus on improving the signage and dynamic information provided to the public, as well as the implementation of traffic enforcement measures. We recommend the installation of the following measures to encourage public safe behavior:

- Installation of blank out no left turn sign,
- Installation of a second train signal to advise motorists and pedestrians that two trains are approaching an intersection,
- Installation of illuminated active in-pavement marking (IPM) systems, and
- Installation of traffic enforcement devices.

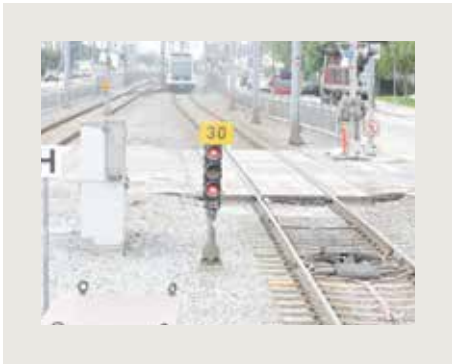
This intersection includes most of the basic vehicle and pedestrian signs, with the exception of the “No Vehicle on Track” sign and “Do not Stop on Track” sign.

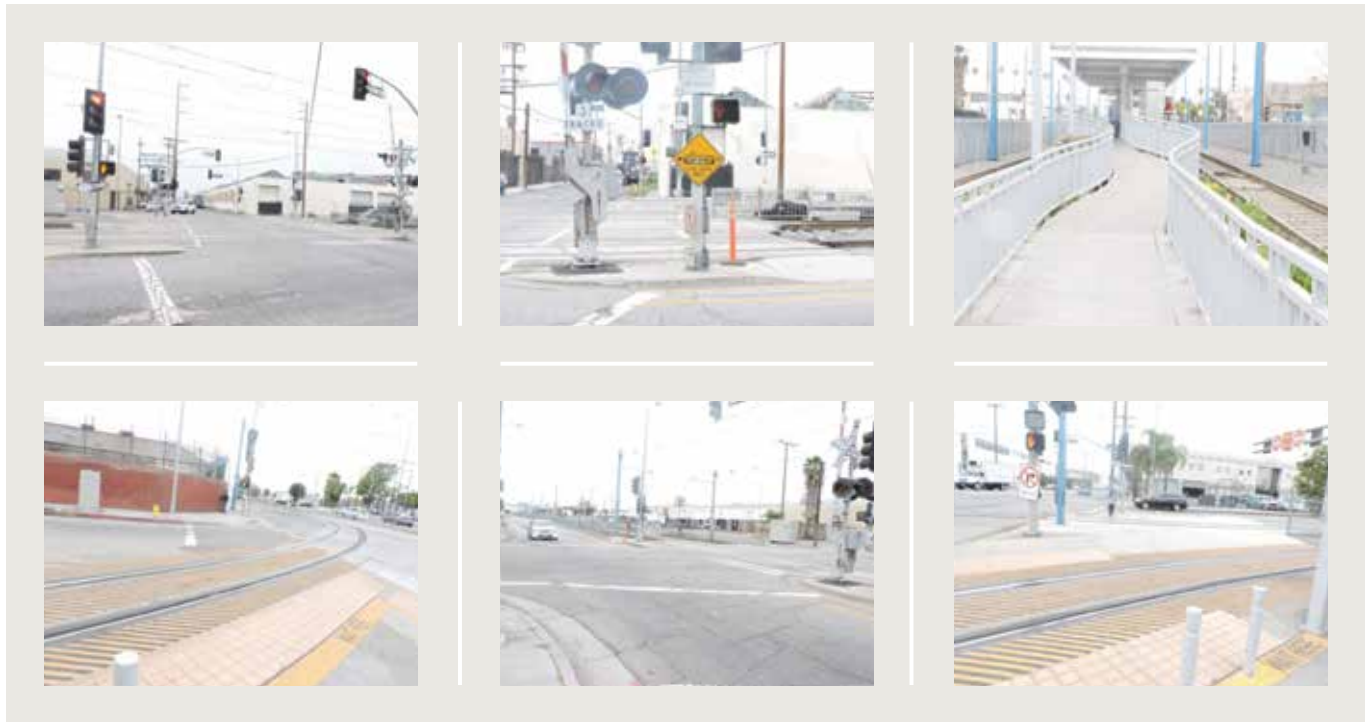
Street Markings

The 20th Street intersection (south end of Washington Station) does not have street markings or channelization to guide pedestrians through the crossing. Further, there is no street marking or treatment to mark the edge of the crossing. However, the north end of the station has channelization to guide pedestrians to exit the station. Further, street markings north of the station employ contrasting pavement color or texture for pedestrian crossings.

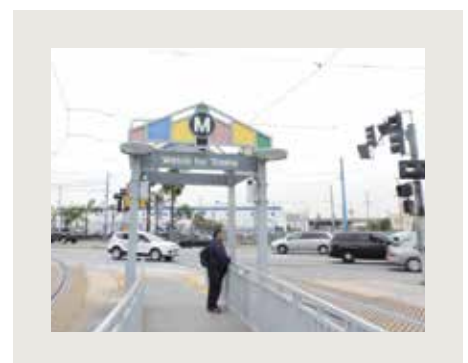
Traffic Equipment

The 20th Street intersection is equipped with basic crossing gates, flashing lights and bells for vehicles. There are no pedestrian flashing lights, gates or bells at this intersection. The only pedestrian crossing lights at this intersection are countdown lights that are manually activated by pedestrians.

Other than a sign for pedestrian to “Watch for Trains”, there is no other protection provided. Pedestrians are provided with a zone to wait for the clearing of the countdown crossing signals to clear. However, there are no provisions provided for pedestrians waiting between the tracks to activate the crossing signals.

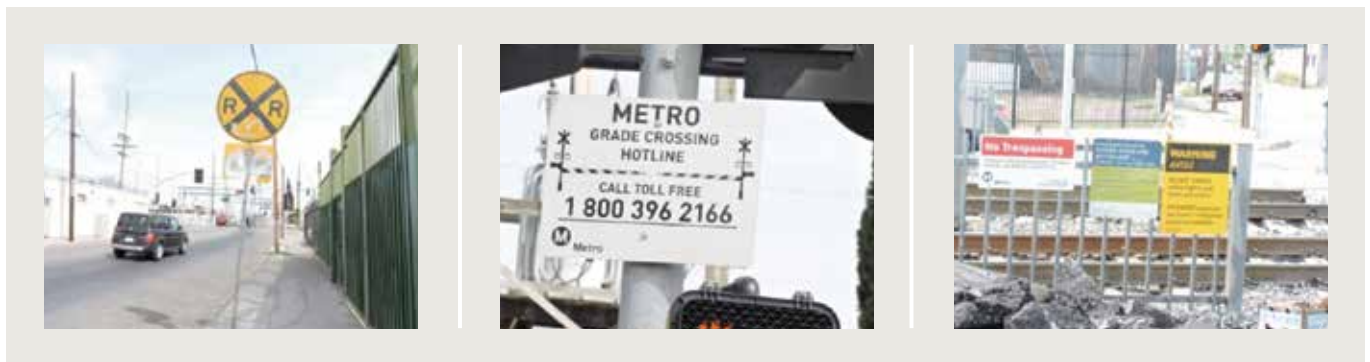
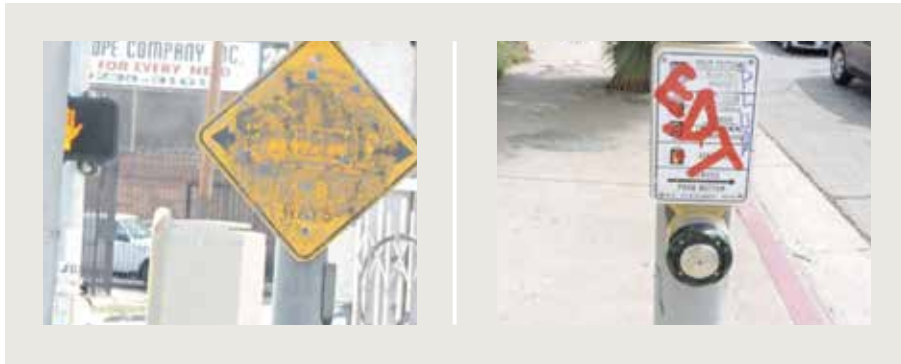
Signage

There are a number of pedestrian and vehicle signs that are not provided at this intersection. These includes:

- No vehicle on track sign,
- No pedestrian sign, and
- “Stop here when flashing” sign.

Further, a number of signs at this intersection are covered with graffiti.

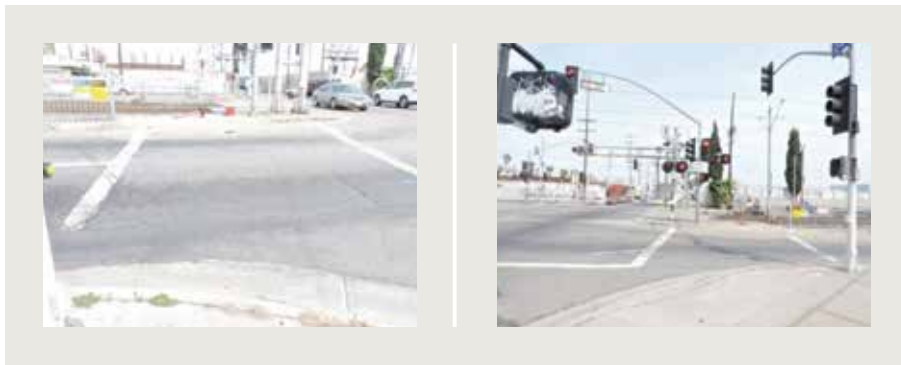
Street Markings

There are no street markings or channelization to guide pedestrians through the crossing. Further, there is no street markings or treatment to mark the edge of the crossing.

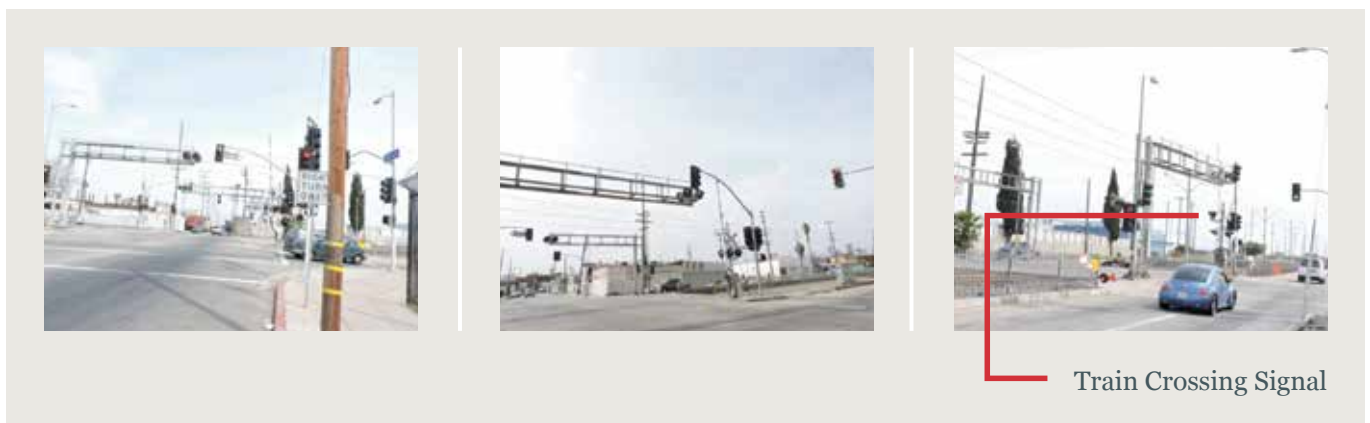
Crossing Equipment

This intersection is equipped with basic crossing gates, flashing lights and bells for vehicles. There are no pedestrian flashing lights, gates or bells at this intersection. The only pedestrian crossing lights at this intersection are countdown lights that are manually activated by pedestrians.

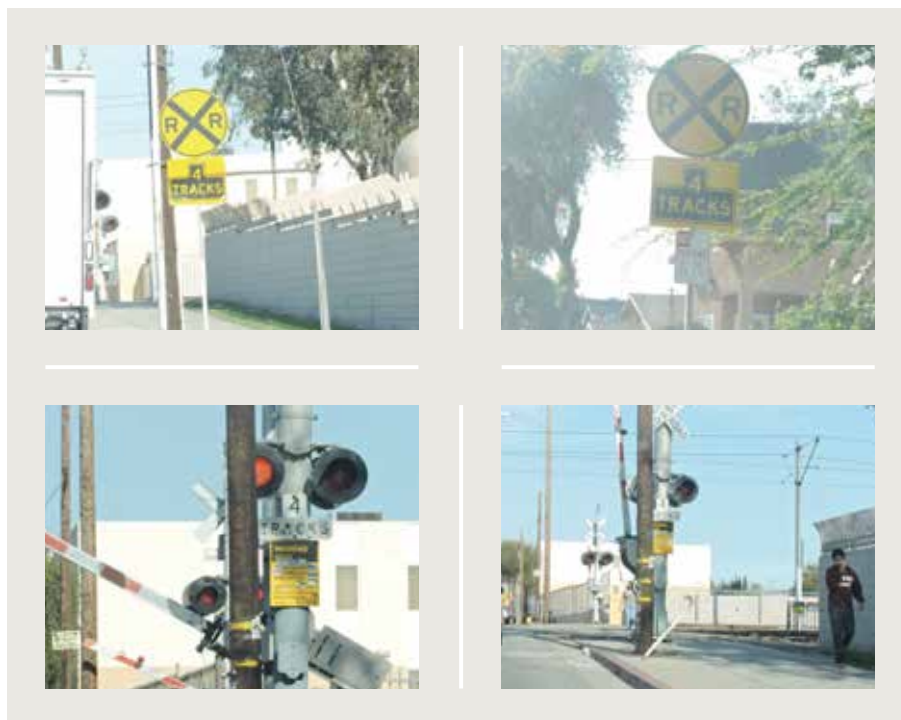
There are a number of pedestrian and vehicle signs that are not provided at this intersection. These include:

- Look signs,
- No vehicle on track sign,
- Emergency notification sign,
- No pedestrian sign, and
- “Stop here when flashing” sign.

To enhance the safety of operation at this location, it is essential to undertake measures that will discourage public unsafe behavior. This can be achieved through the installation of additional signs, street markings & traffic equipment, and by implementing a channelization scheme to guide pedestrians through the crossing. Further, the implementation of dynamic information related to approaching trains will inform the public when more than one train is approaching the intersection. A contributing factor to one fatality at this intersection is related to a second train that struck a pedestrian. Appendix 8 identifies a number of industry best practices to improve the safety at rail/vehicle intersections. The implementation of a number of these measures at this location will help achieve an environment that will encourage safe public behavior.

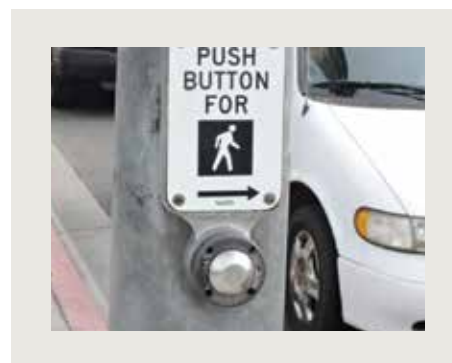
There are a number of pedestrian and vehicle signs that are missing at this intersection. They include:

- Advance warning signs,
- Look signs,
- No vehicle on track sign,
- No pedestrian sign,
- Do not stop on track sign,
- Stop here on red sign, and
- Suicide crisis line sign.

- Installation of blank out no left turn sign,
- Installation of a second train signal to advise motorists and pedestrians that two trains are approaching an intersection,
- Installation of illuminated active in-pavement marking (IPM) systems, and
- Installation of traffic enforcement devices.

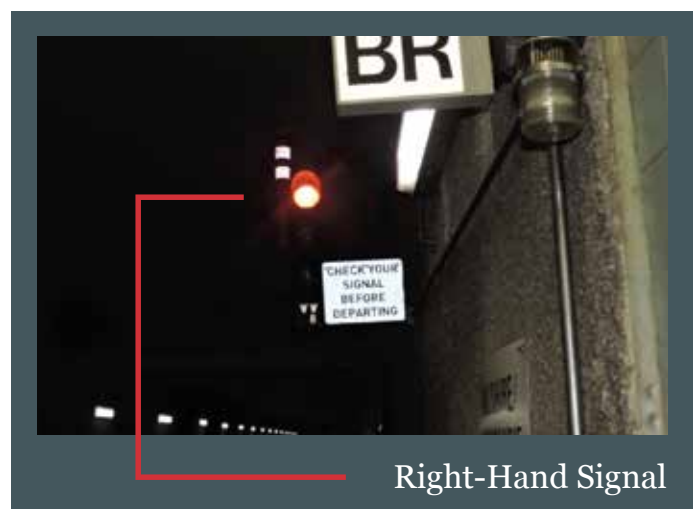
- Although Metro signal standards require signals to be installed on the left of the track, Signal 8 is a right hand signal,

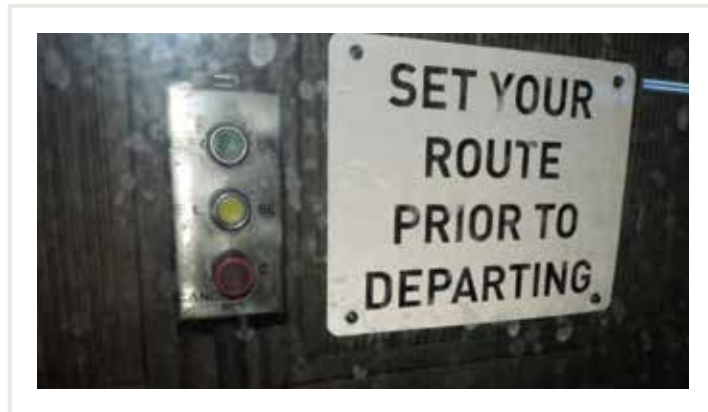
- The motorman pushbutton at the location does not include an indicator to inform the train operator if it is necessary to establish the route at the signal, and

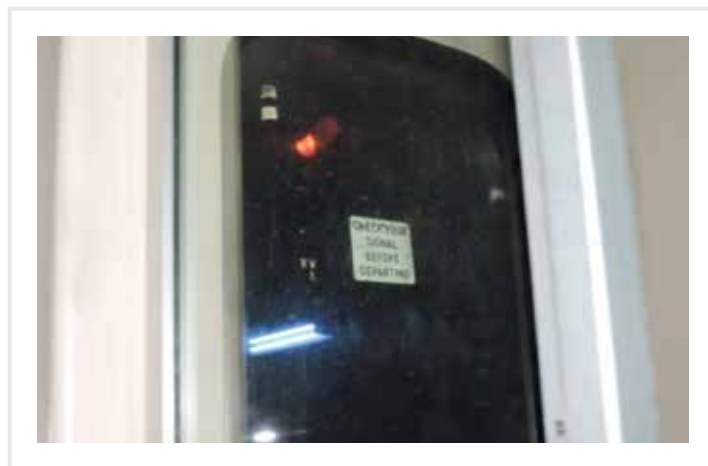
- When the train operator's cab is aligned with the motorman pushbutton location, Signal 8 is not visible from the train operator's position. The train operator needs to lean to the right side of the cab to see the signal.

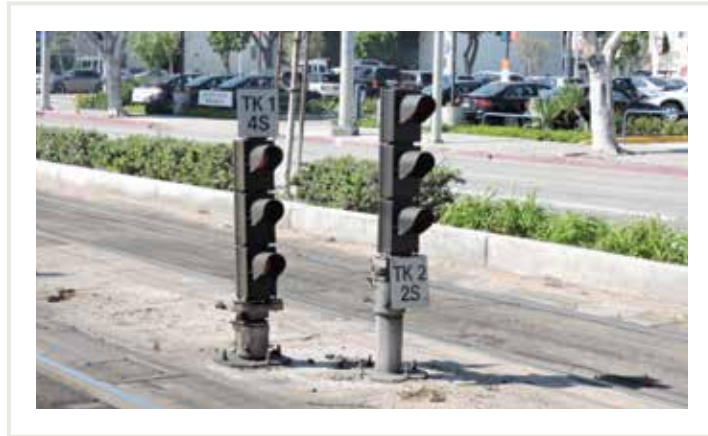
The site visit revealed that signals 2S and 4S have good visibility. However, these southbound signals are installed side-by-side, which is contradictory to basic training provided to train operators.

Similar operating conditions exist at northbound signals 2N & 4N: good visibility however, the signals are installed side-by-side.

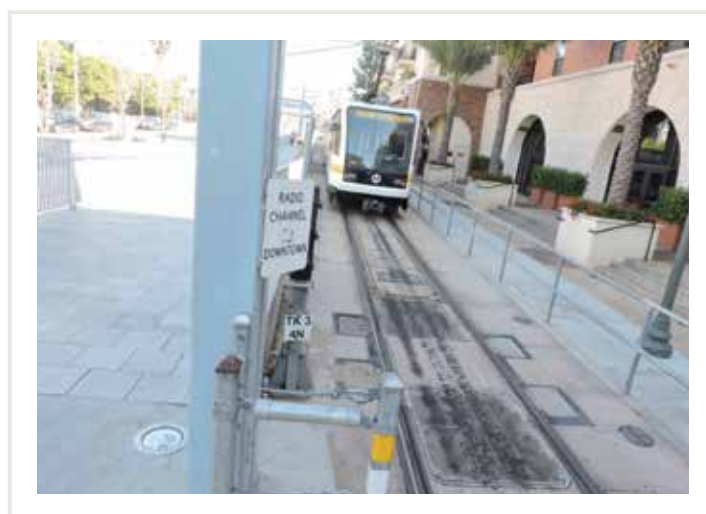
- Reverse running signal 4S is installed on the right side of the track,
- There is a slight curve in the approach to signal 2S, and
- A “radio” sign is partially obstructing signal 4N at the north end of the station.

The Stop Signal Working Group did identify the curve in the approach to Signal 2S as a potential contributor to red signal violation. It was indicated that it is difficult to see the signal from 500 feet. However, the signal representative indicated that there is a restricted speed approaching the station, and train operators should be slowing down.

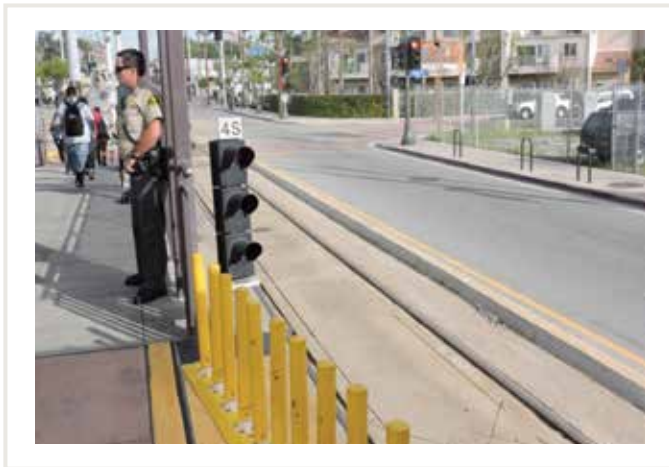
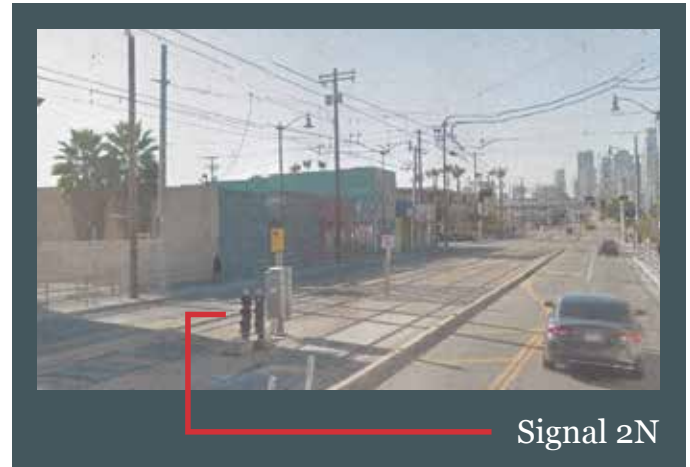
The Stop Signal Working Group noted that the barrier is partially obstructing the view of Signal 4S.

There are no site specific factors that contribute to red signal violations. Although Signal 4S is partially obstructed, the signal is visible when a train is stopped at the station. However, similar to other locations, there are operational factors that can contribute to the violations:

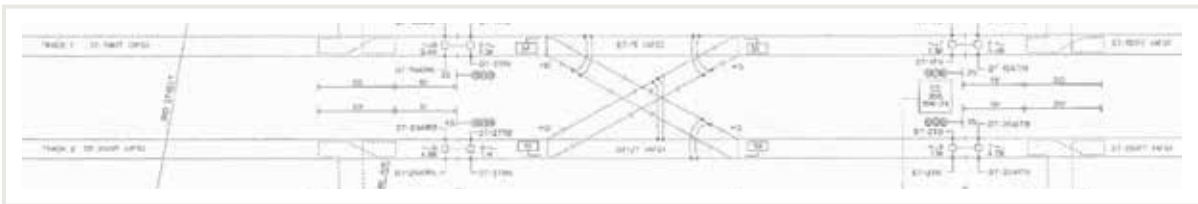
A review of the red signal violation reports during the years 2010 through 2015 indicates that nine (9) red signal violations took place at Ditman Interlocking.

Metro investigated these violation incidents and concluded that the root causes for all nine incidents are attributed to “Operator Inattention”. No contributing factors were reflected in the reports.

In view of multiple violations at this location, our team conducted a number of interviews with Metro’s Operations personnel, and inspected the physical signal installation to determine if there are other factors that contributed to the violations. Further, our team reviewed the Site Visit Reports provided by the Metro’s Stop Signal Working Group, as well as the ROC Controller SOPs and the Gold Train Operator SOPs.
