**Los Angeles County
Metropolitan Transportation Authority
Office of the Inspector General**

**Review of Metro Rail
Service Disruptions**

Report No. 18-AUD-03

October 24, 2017

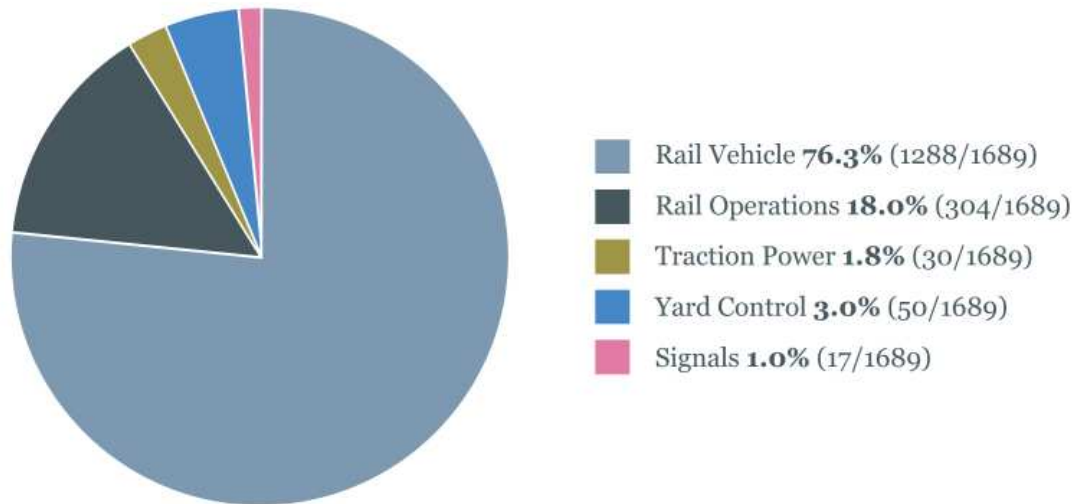
Figure 1: Distribution of Top Three Light Rail Incidents

B2. Rail vehicle incidents and rail operations incidents were the top two service delay incidents across each of the four light rail lines, accounting for nearly 95% of the 1,689 delay incidents (76.3% rail vehicle incidents and 18.0% rail operations incidents). See Figure 1.

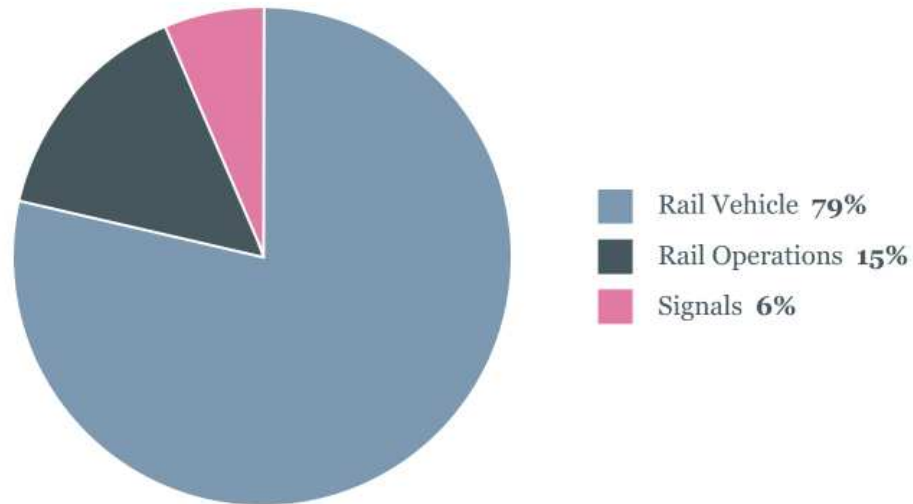
Figure 3: Distribution of Top Three Subway Incidents

B5. The top three causes of delay on MRL represented 86.7% of total number of MRL delay incidents in 2016 as identified in the data provided (170 incidents of the 196 total).

B6. Rail vehicle delays comprised 79% of the top three causes, as shown in Figure 3:

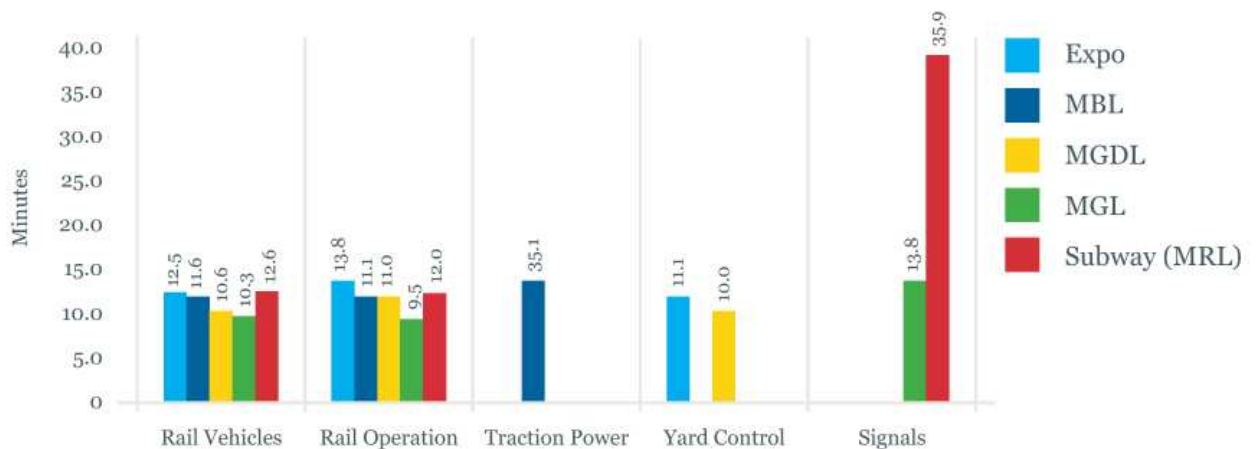
Figure 5: Average ‘Maximum Delay’ Minutes for Top Three Incidents Per Line

B10. The average maximum delay minutes were also highest for traction power and subway signal incidents. (see Figure 5.)

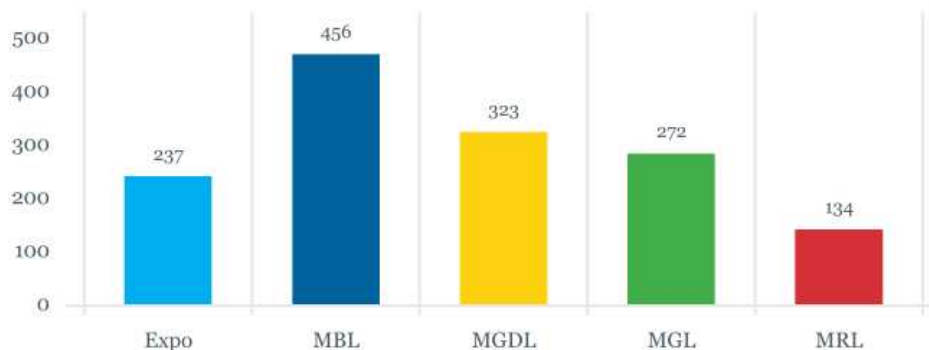
Figure 6: Rail Vehicle Incidents by Line

Based on the information from the ROC, a total of 1,422 rail vehicle incidents were recorded for 2016, 1,288 on the four light rail lines and 134 on the subway. (For subways, Metro Purple Line is incorporated into Metro Red Line for this report.) The MBL, which has the largest fleet, had the most rail vehicle incidents. (see figure 6.)

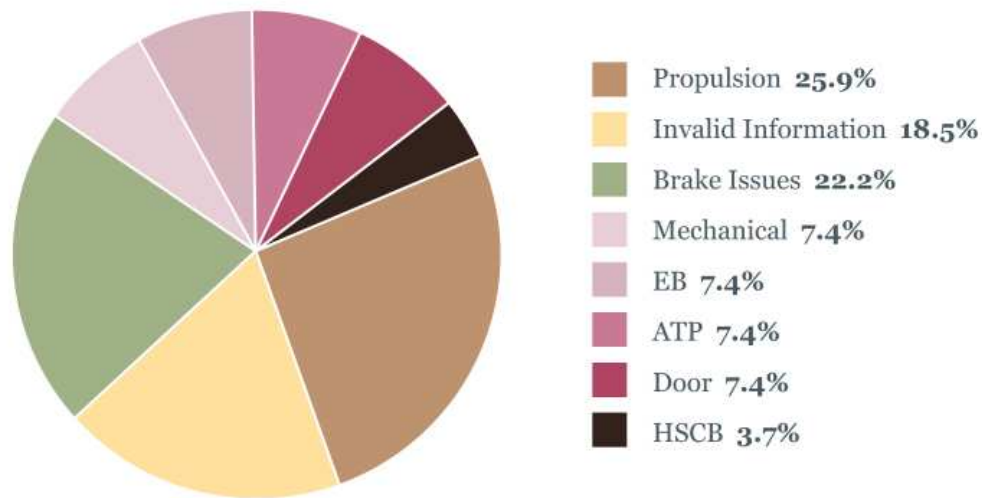
Figure 9: No Issues Identifiable (P865 & P2020)

- Figure 9 below classifies “No Issue Identifiable” incidents by the “Cause” of the delay as reported to the ROC.
- The average maximum delay of these “unidentifiable” incidents was 10.8 minutes.

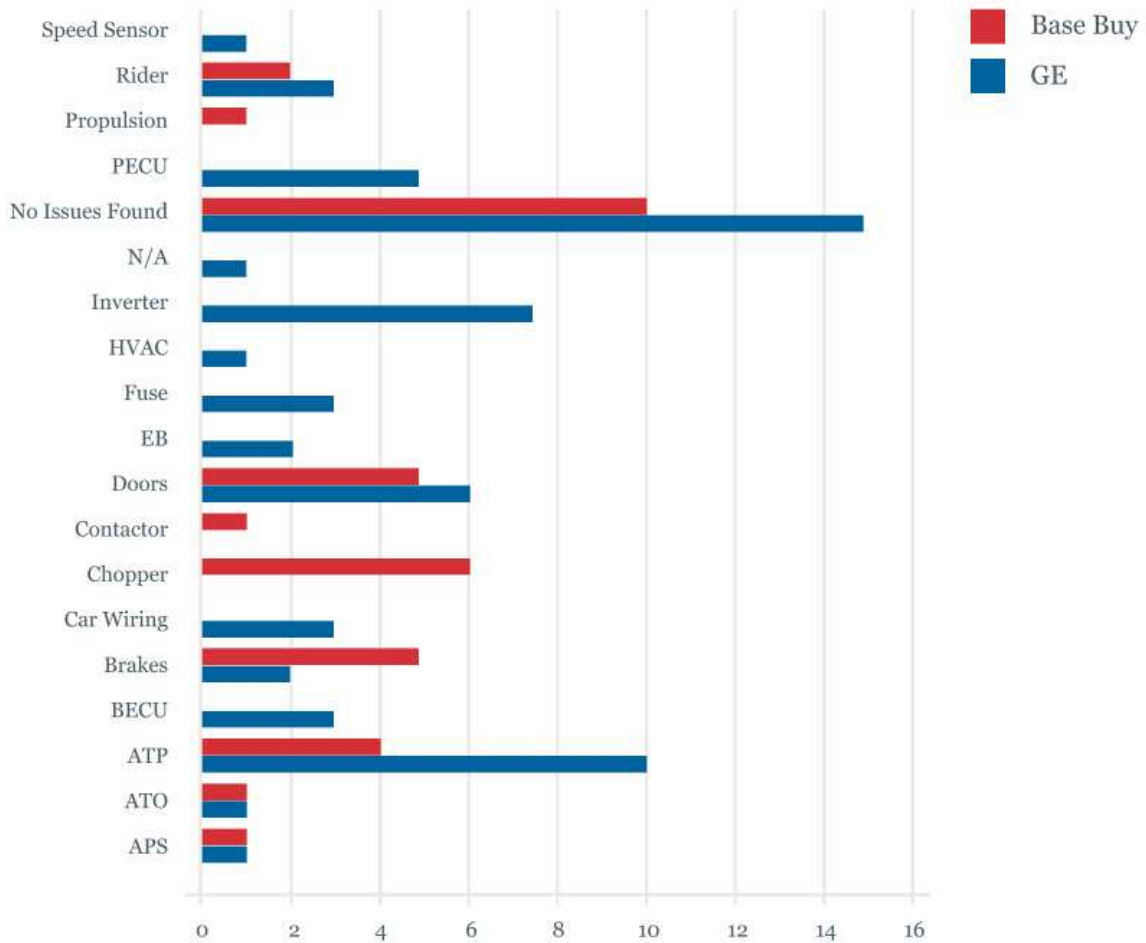
Figure 14: Causes of Rail Vehicle Incidents - Subway

The subway fleet consists of 30 Base Buy cars and 74 newer A650 General Electric (GE) cars. Review of sample incident reports for 2016 revealed that the Base Buy cars had a higher incident rate per vehicle than the GE cars. GE cars had more total incidents since they consist of 71% of the total subway fleet. Most of the vehicle components for the GE and Base Buy fleets are identical, other than the propulsion system and vehicle controls. Figure 14 below shows the number of rail vehicle incidents by causes.

1. Base Buy 1.2
2. GE 0.82

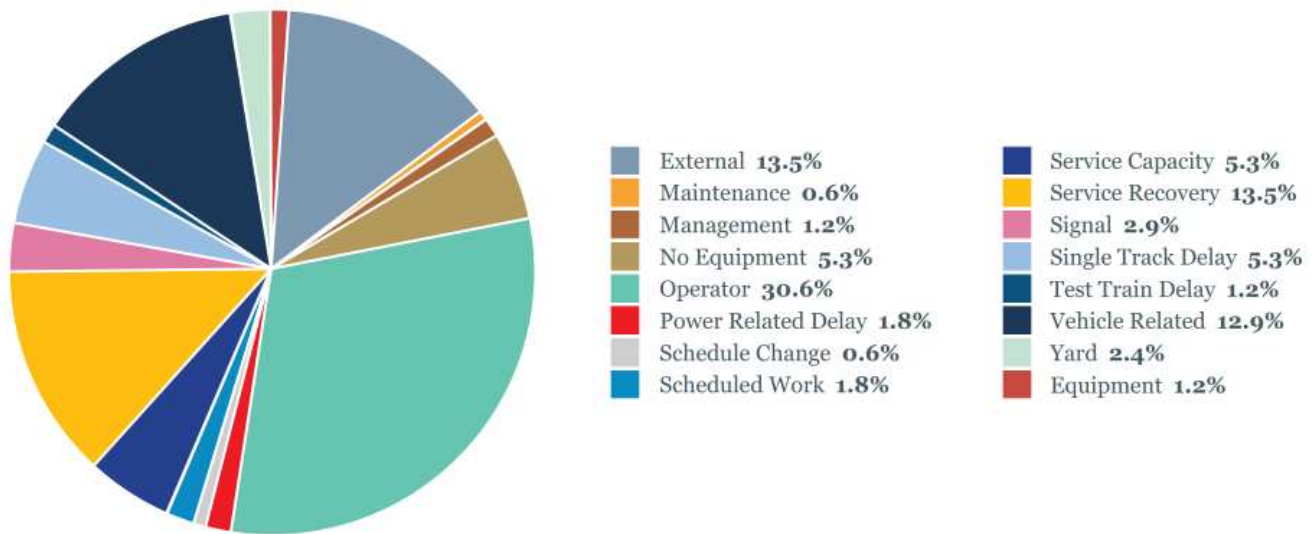
Figure 19: Causes of Rail Operations Incidents (Light Rail)

A sampling of 170 of the Light Rail Operations incidents were examined to further assess the types and related causes of incidents. These incidents were categorized into 16 primary causes of Light Rail Operations delay incidents. (see Figure 19.)

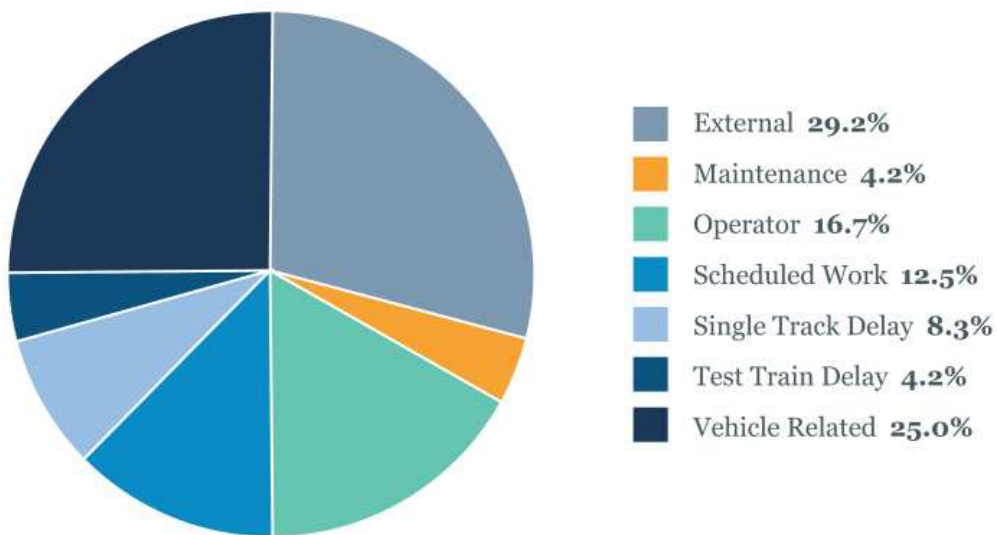
Figure 20: Causes of Rail Operations Incidents (Subway)

Similarly, the 26 delay incidents attributable to rail operations on the MRL were categorized into seven primary causes. (see Figure 20 below.)

D3. On the MRL, operator caused incidents accounted for 16.7% of the 26 Operator related incidents. (see Figure 20 above.)
