**Los Angeles County  
Metropolitan Transportation Authority  
Office of the Inspector General**

**Review of Metro Call Boxes in  
Rail Stations and Major Bus Terminals**

**Report No. 26-AUD-01**

**August 22, 2025**

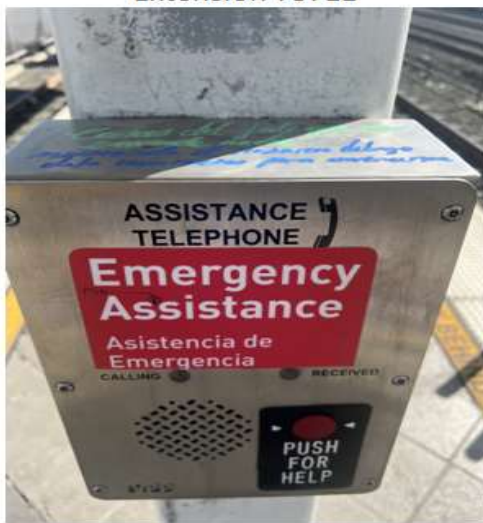
Picture 1: A Line – Florence  
Extension 73711

We observed graffiti and unclean conditions on 37 call boxes, surrounding elevator doors, and on phones provided by elevator service vendors. We also noted that several call boxes exhibited rust, accumulated dirt, and surface damage. Please see Table 3.

These conditions create a perception of neglect and potentially reduce customers' use of the system. Regular maintenance and cleanliness are essential to ensuring the call boxes are

Pictures 1 and 2 are examples of graffiti-ridden call boxes.

- Enhance routine inspection and cleaning protocols, especially in stations with high ridership (including elevator areas), to ensure all units are clean and free of graffiti.

- Establish anti-graffiti measures and increase surveillance, or use other methods, to deter vandalism.
- Conduct a staffing assessment to ensure sufficient personnel are available to effectively respond to and prevent vandalism and graffiti-related incidents and repairs.

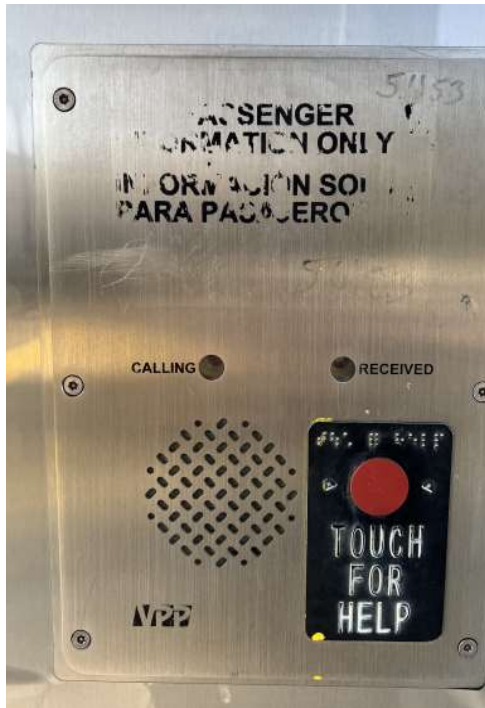
Picture 3: E Line – Expo/Crenshaw  
Extension 56153 – Faded Number

We noted that several call boxes were either incorrectly numbered, not numbered, or displayed faded and unreadable labels, especially the numbers written manually. See Pictures 3 and 4.

Some call boxes were labeled with handwritten extension numbers, while others had typed labels affixed to them. Currently, Metro labels call boxes with an extension number for identification and operational purposes.

A call box ID functions like its “address” in the system. Call box identification helps Operations staff quickly locate and identify call boxes and locations that require service or an emergency response. Inaccurate or missing identifiers hinder timely maintenance and emergency response. An incorrect or missing ID can cause call box service delays, missed repairs, or wasted resources spent searching for the correct unit.

- Standardize numbering protocols across all stations and provide durable, clearly visible labels for identification and operational purposes.
- Ensure all numbering and signage is correct and resistant to vandalism and internal and external environmental conditions.
